## NRAY Neutron Radiography Sample Image - Braze Quality Evaluation

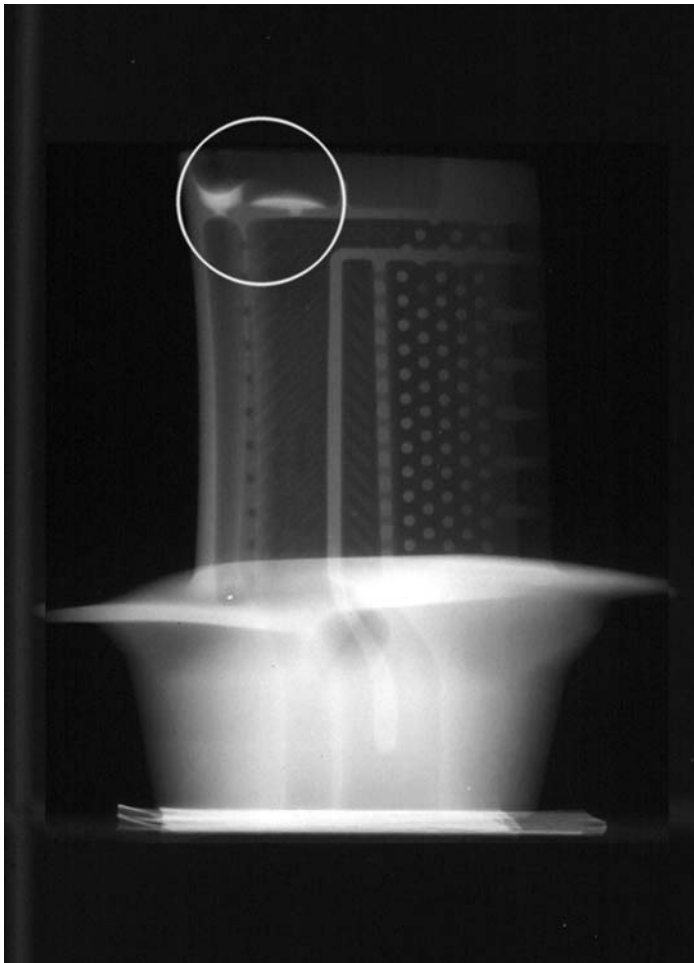
The white material in the circled portions of the neutron radiographs of turbine blades, shown above, is brazing. In the part on the left, the braze is present, intact and completely covers and seals the holes beneath it. In the part on the right, the braze, although present, is of poor quality and does not completely seal the holes as was intended. Neutron radiography has effectively imaged braze presence and quality in manufactured parts.
