NRAY Neutron Radiography Sample Image - O-Ring Placement

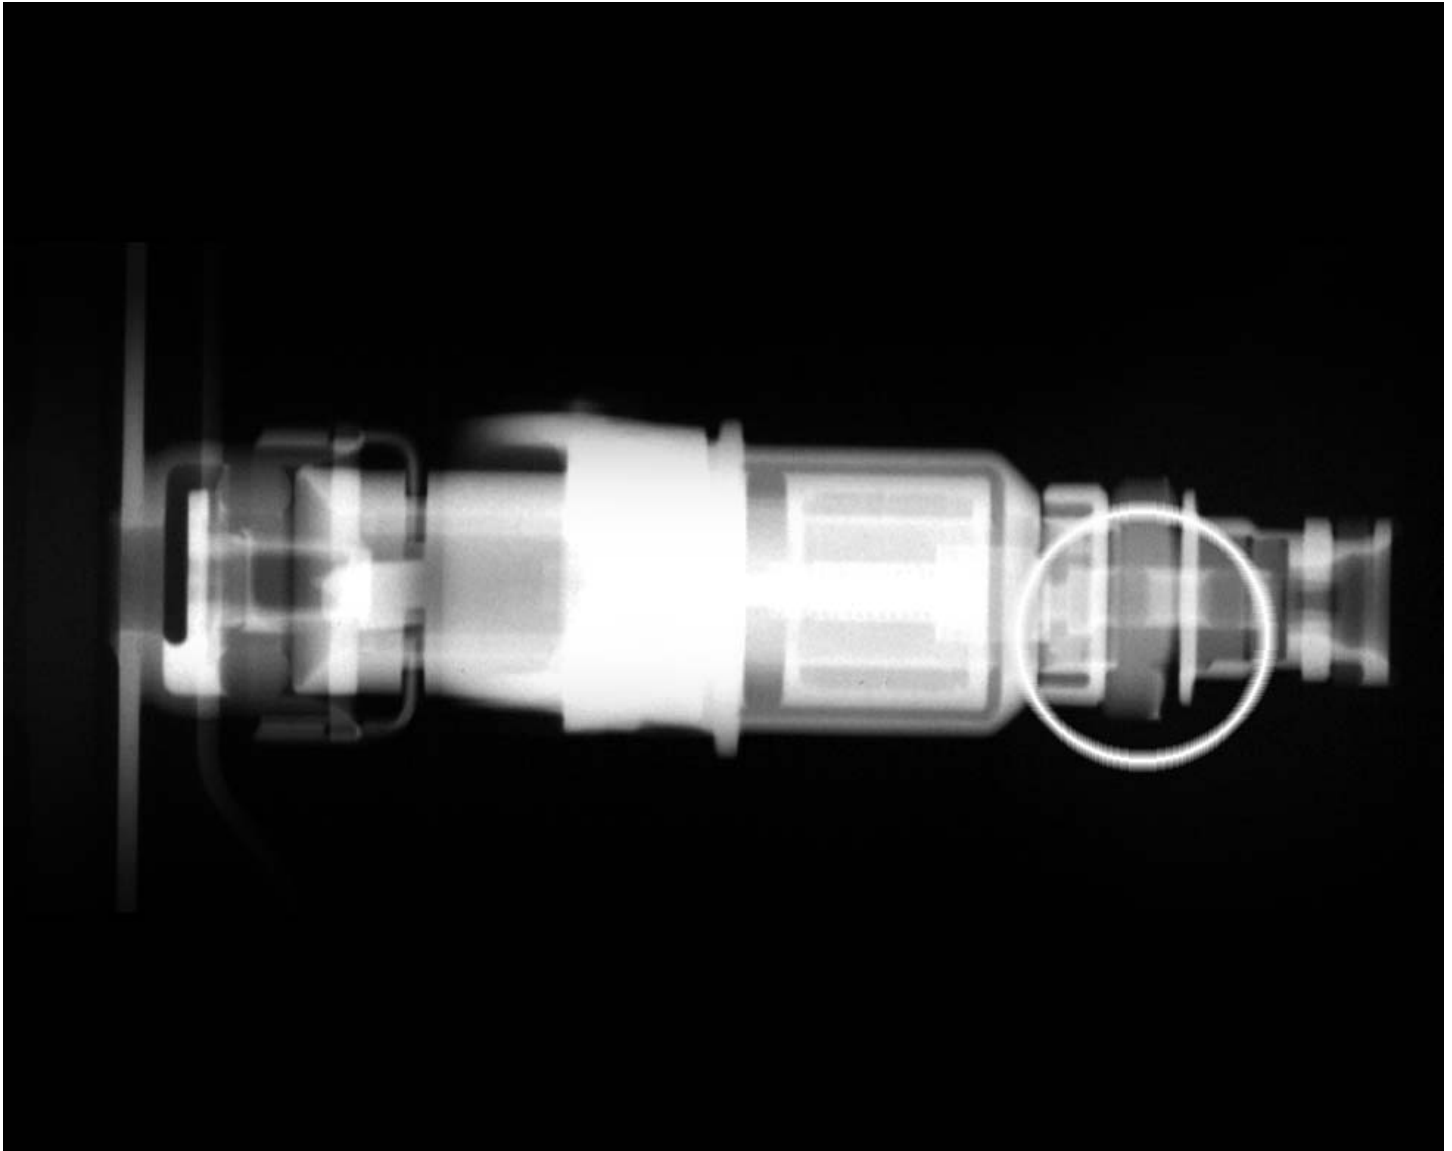
The image above is a neutron radiograph of a fuel injector base component. The o-ring between the injector and the base is identified in the image by a circle. It is clearly seen that the o-ring in question is misaligned. Neutron radiography is a very useful and effective technique for identifying missing or misplaced o-rings.
